Environmental Assessment
From an
Indoor Air Quality (IAQ)
Perspective

At
3 Valley Road
New Idaho NJ 94T18

Performed for:
Mr. and Mrs. Bird

By
Sal La Duca
Indoor Environmentalist
Environmental Assay Inc.
P.O. Box 610
Plymouth IN 46563-0610
eainc@emfrelief.com
www.emfrelief.com

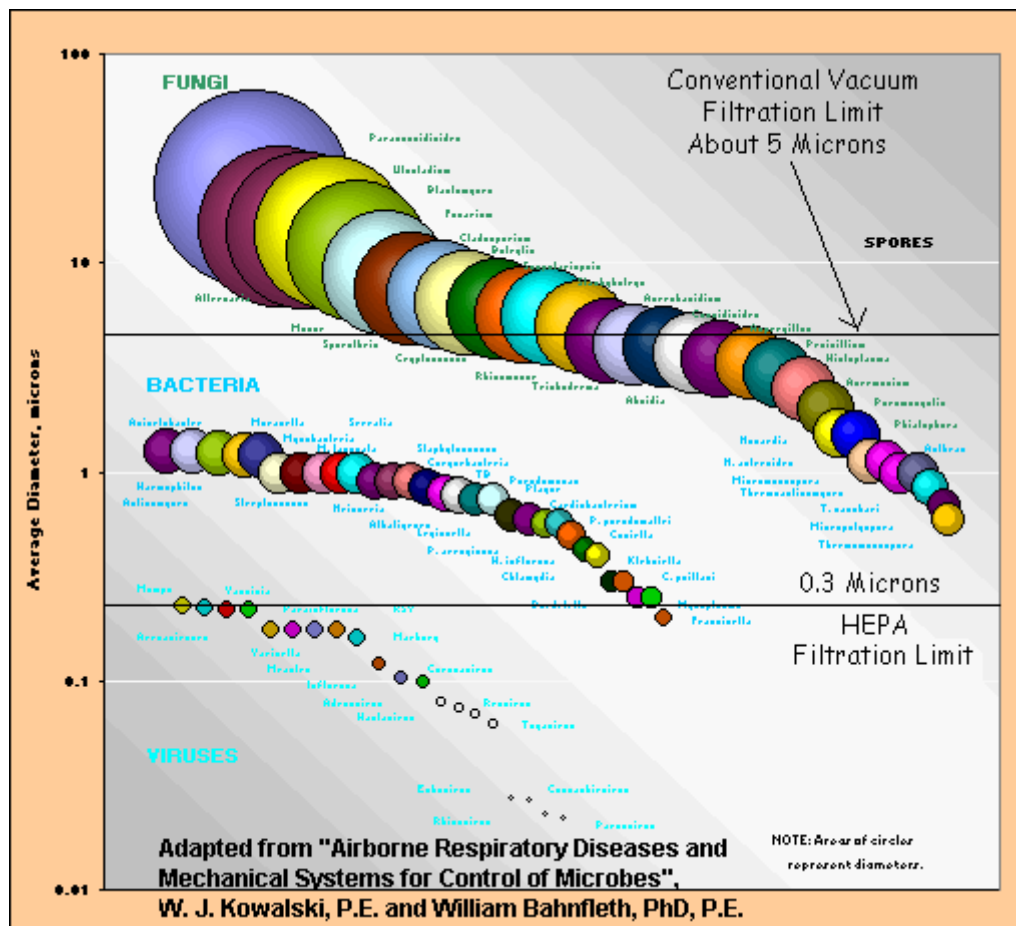
Note from the above that a HEPA vacuum has a very efficient capture level down to 0.3 microns, which includes all pollen, all mold, most bacteria, and inanimate particulates larger than 0.3 microns. Even occasional use of such a vacuum will eliminate the possibility of dust buildup (*as within carpeting*) that could potentially foster mold growth, regardless of the fact that the RH would have to be elevated high enough to support growth, as **molds need a food reservoir – lots of moisture – and relative darkness (sunlight reduces their life expectancy due to the UV)**. **These conditions not existing indicates that any detected mold were simply a reflection of mold exchanged with outdoors in the process of opening the door to come in or go out, or open windows.**
